# Emergency Water and Weatherproofing System

Belzona 3121 (MR7) is a two component emergency repair and weatherproofing system for the sealing of almost all types of roof surfaces and structures, even during adverse weather conditions. This liquid-applied material is designed for instant waterproofing and can be applied in year-round weather conditions.

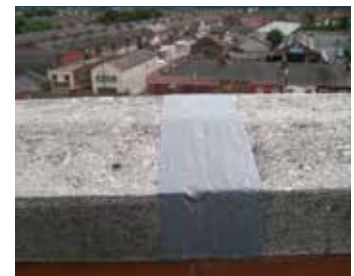
Parapet walls & coping stone joints
