Barrier Coating for Application onto Hot Surfaces

5851

Two-component Belzona 5851 is a barrier coating for the protection of metallic surfaces.

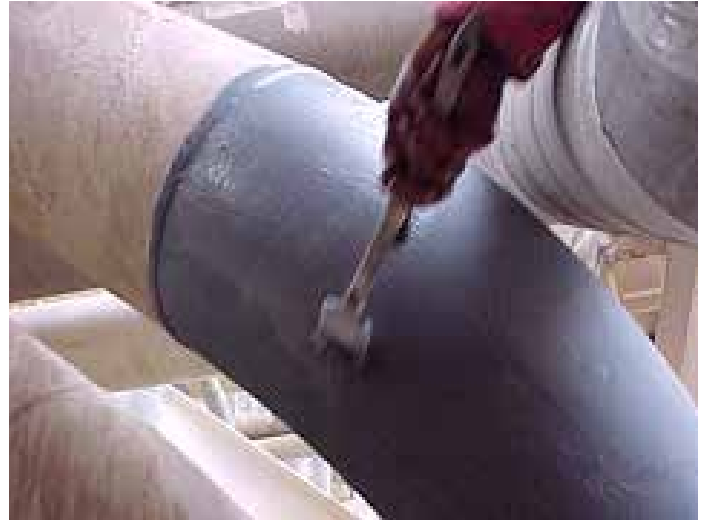
Belzona 5851 used for pipe corrosion protection
