# Coating for Protection of Surfaces Subject to Hot Aqueous and Hydrocarbon Immersion

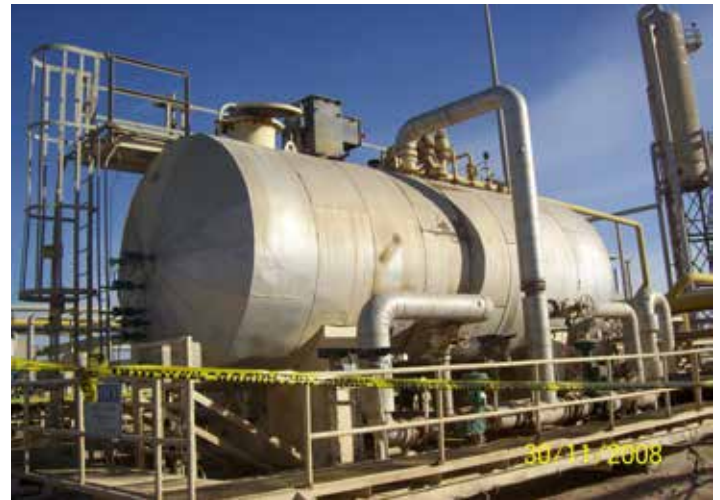
Belzona 5892 used to line a desalter
